Manhole Inspection Summary

Manhole # S15C1_011MH

Location Address: **1717 morrell park av**

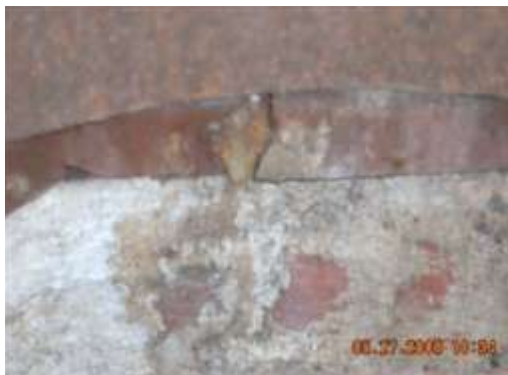
Defect 3

Condition: ☐ Sound ☒ **Cracked** ☐ Root Intrusion ☐ Loose Brick ☐ Deteriorated

cracked chimney brick

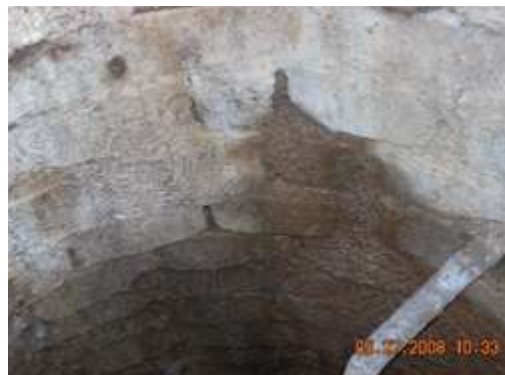
Defect 2

Infiltration: ☐ None ☐ Joint ☐ Cracks ☐ Mortar ☐ Roots ☒ **Wall**

infiltration @ corbel wall

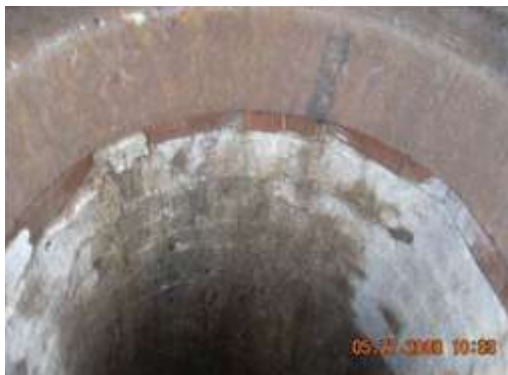
Defect 1

Infiltration: ☐ None ☒ **Joint** ☐ Cracks ☐ Mortar ☐ Roots ☐ Wall

infiltration @ chimney/frame joint

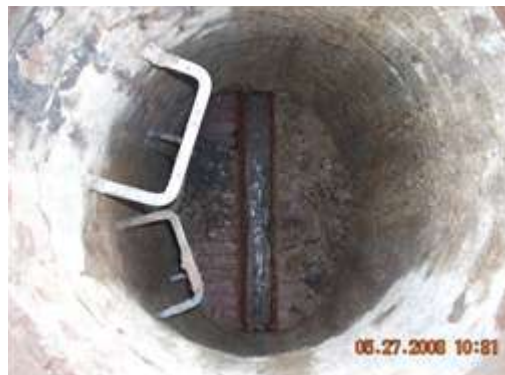
Defect 4

Count: **4** Missing: **0** ☒ **Corroded**

corroded steps

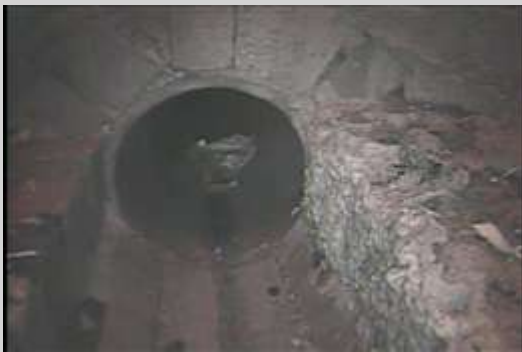
12 O'Clock Outflow

Pipe Height: **8.4** (in.) Rod and Bar (Angled)
Pipe Material: **Clay** ☐ Pipe Lined
Invert Depth: **8.92** (ft.) Flow Characteristics: **Slow**
Deposits: ☒ None ☐ Mud ☐ Sludge ☐ Debris ☐ Grease
Silt Depth: **0** (in.) Deposits Extent:
Infiltration: **None** Pipe Seal Cond: **Sound**

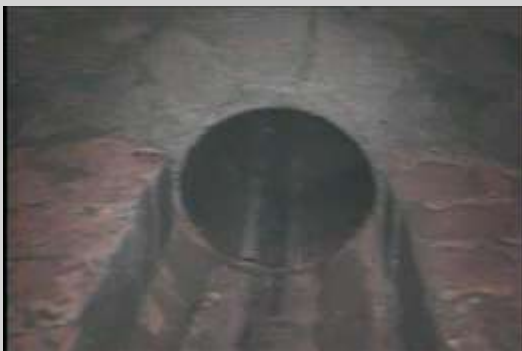
6 O'Clock Inflow

Pipe Height: **8.4** (in.) Rod and Bar (Angled)
Pipe Material: **Clay** ☐ Pipe Lined
Invert Depth: **8.70** (ft.) Flow Characteristics: **Slow**
Deposits: ☒ None ☐ Mud ☐ Sludge ☐ Debris ☐ Grease
Silt Depth: **0** (in.) Deposits Extent:
Infiltration: **None** Pipe Seal Cond: **Sound**
